QA-98

Sterling Price Farm  
Centreville vicinity  
Private

## INVENTORY FORM FOR STATE HISTORIC SITES SURVEY

Sterling Price, Jr. Farm, Seegar Farm

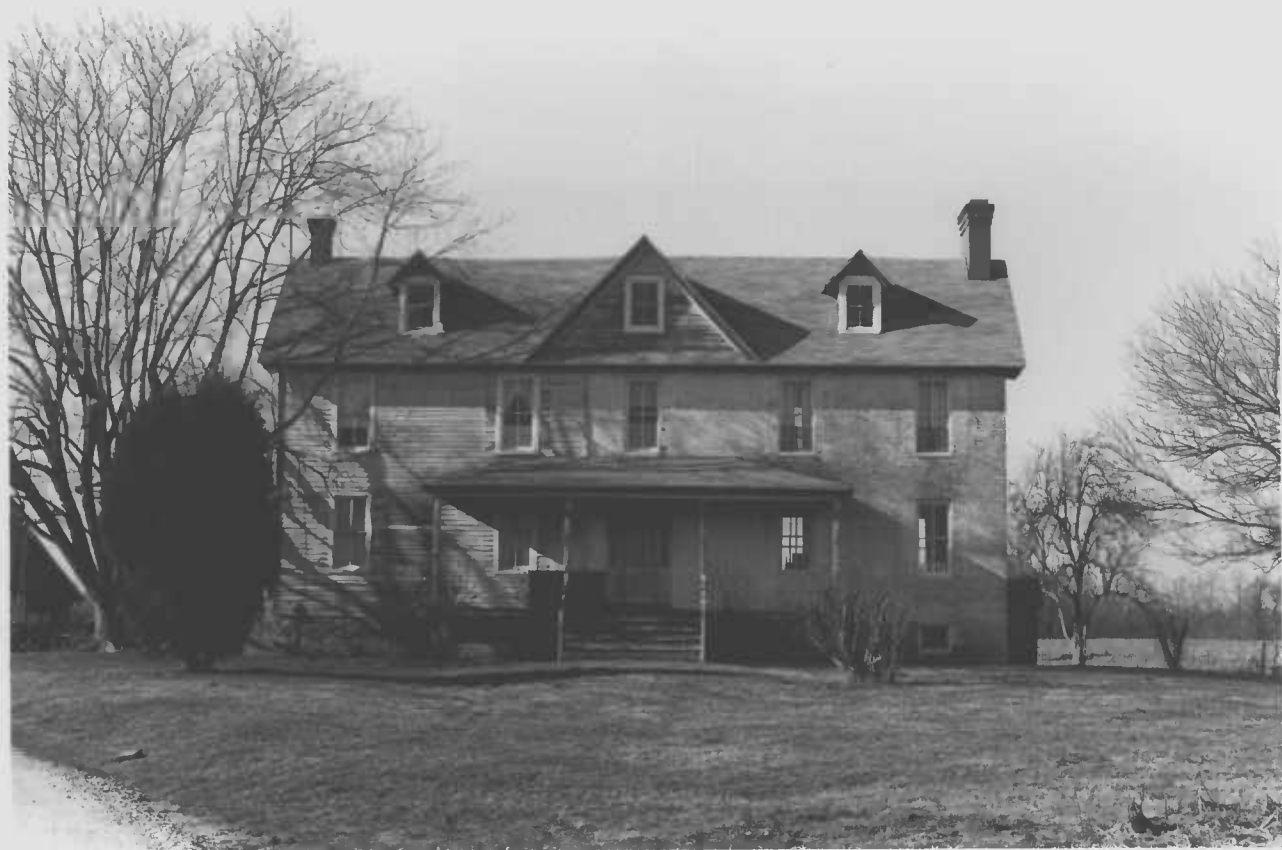
QA-98     Sterling Price, Jr. Farm  
            Centreville vicinity  
            Orlando Ridout V 1981  
            East (front) facade

The front facade of the dwelling house faces east, toward Rolling Bridge Road. The original brick section is laid in five-course bond with no water table, belt course, or corbeled cornice. The door is located in the south bay on the first floor, with two large 2/2 windows to the north. There are three 2/2 windows across the second floor, and six-light cellar windows below each first floor opening. Both jambs of the door opening have been reworked and all of the first and second floor window openings have been enlarged. The entrance door is a highstyle Eastlake door with sidelights and a transom. The frame 1893 addition to the south has two 2/2 windows on each floor. It rests on a continuous brick foundation and is covered with plain horizontal weatherboards. The roof of the early house was extended to the south, and a cross gable was constructed in the center of the enlarged facade, straddling the two sections of the house. The cross gable is flanked on each side by a single 2/2 pitched roof dormer window. The roof is now covered with asphalt shingles and the eaves are boxed. The early chimney on the south gable was rebuilt with a characteristic Victorian corbeled cap. Two bricks in the east face of this chimney are inscribed with

the date "1893" and the name "F. YEATS". A similar flush chimney rises at the center of the south gable. A one story open porch protects the center three bays of the enlarged house on this facade.

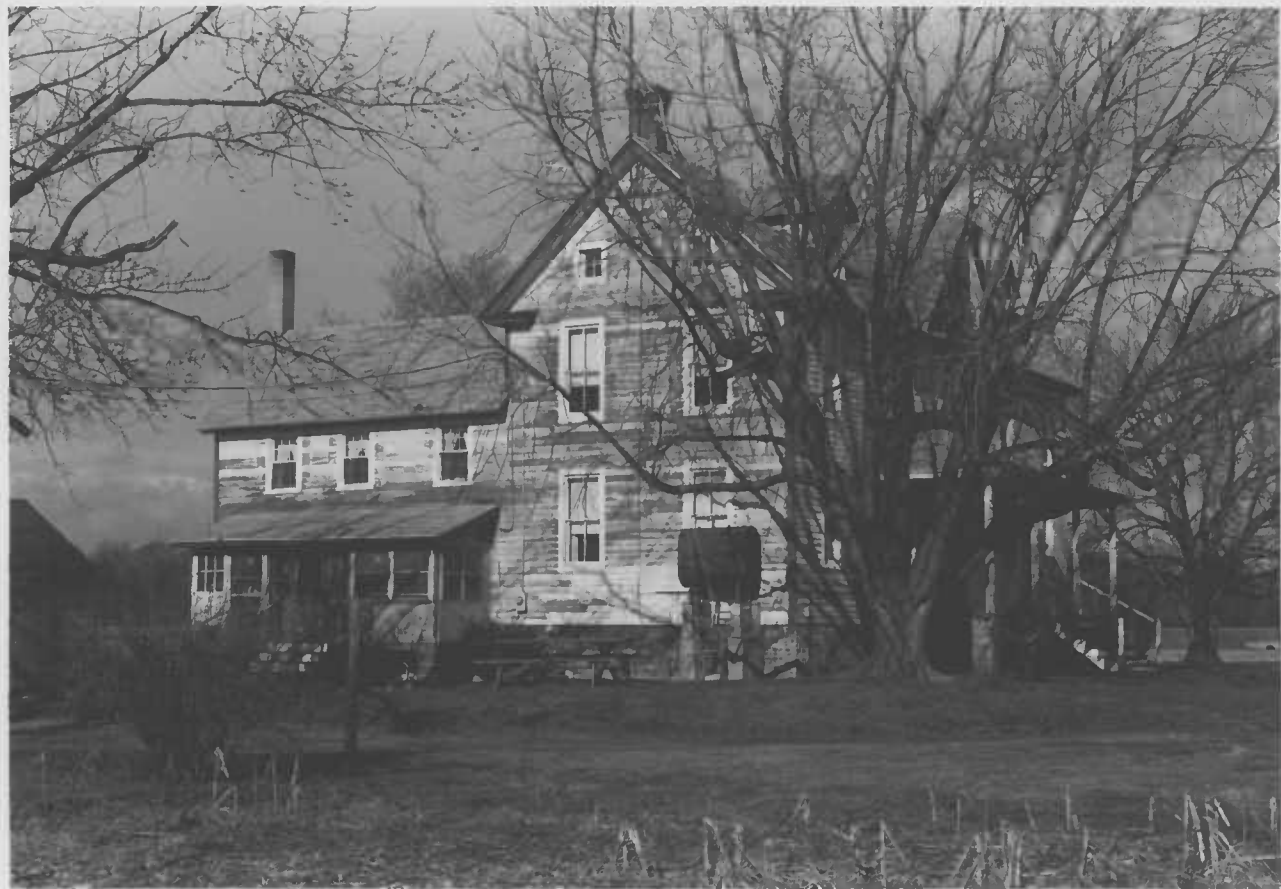
QA-98

Sterling Price, Jr. Farm  
Centreville vicinity  
Orlando Ridout V 1981  
View from Southeast

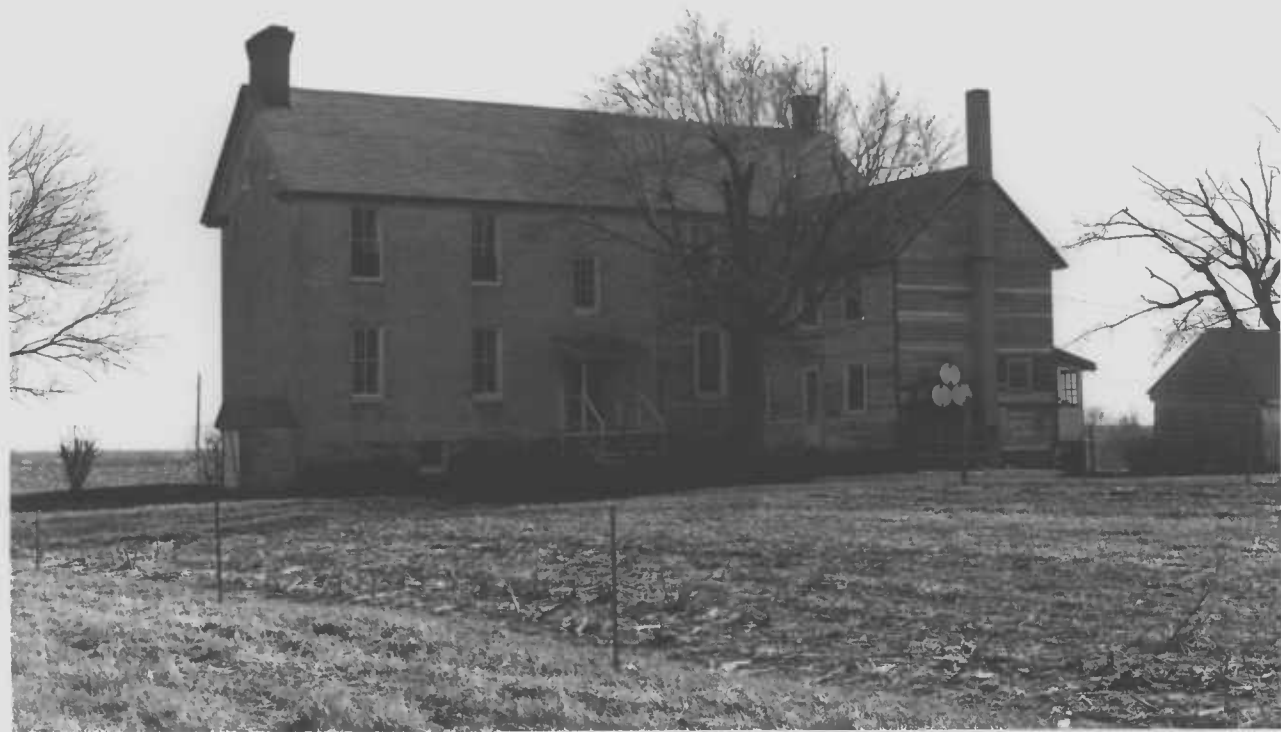
QA-98     Sterling Price, Jr. Farm  
            Centreville vicinity  
            Orlando Ridout V 1981  
            Rear (west) facade

The rear facade of the brick section is also laid in five-course bond with the same painted "water table". The door is in the south bay, with two 2/2 windows to the left. On the second floor, there is a 9/6 window downset above the door to light the stair landing, and two 2/2 windows to the left. The 2/2 windows are set in enlarged openings, but the 9/6 window is original and the opening has not been reworked. The door opening is also untampered, and is fitted with a handsome six-panel Federal door. There are two six-light cellar windows but no dormers.

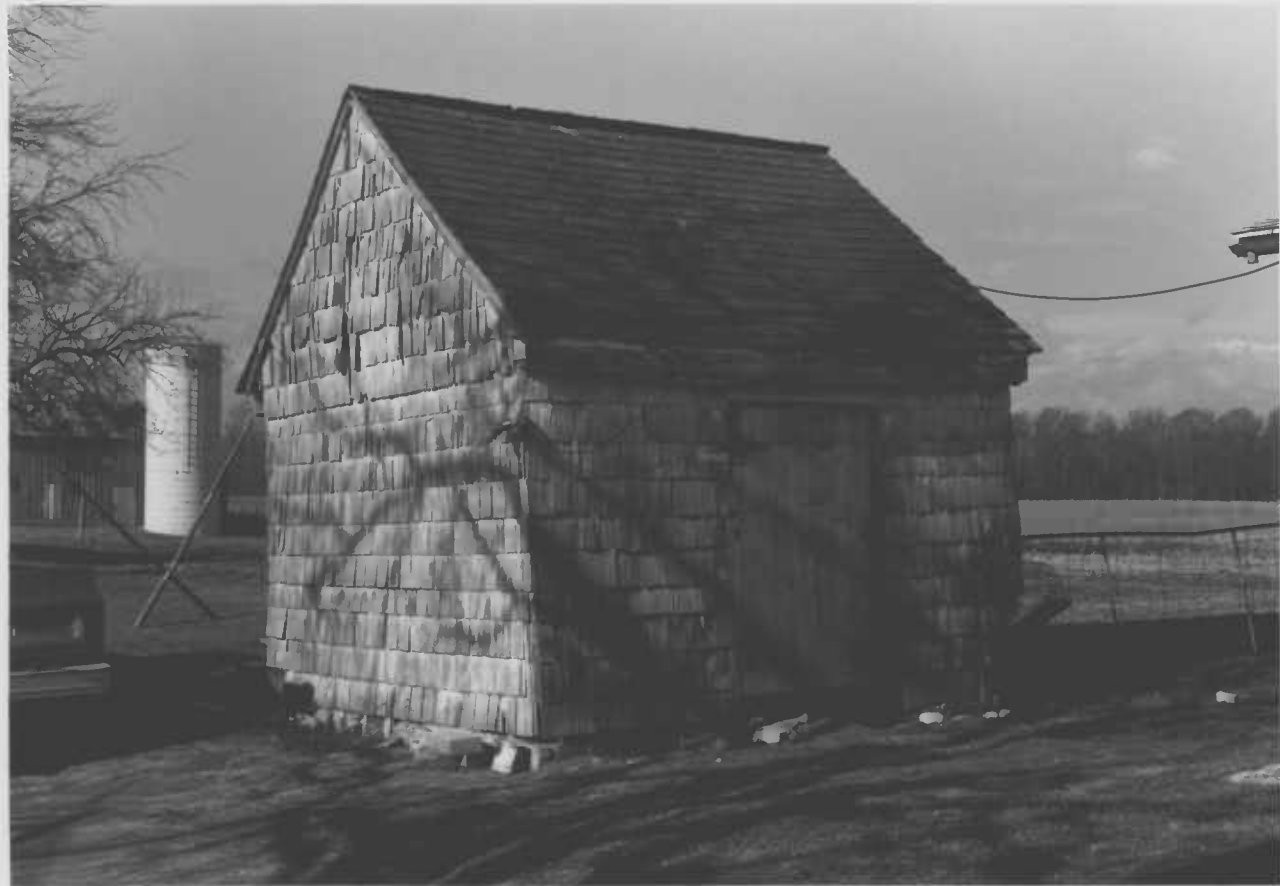
QA-98

Sterling Price, Jr. Farm  
Centreville vicinity  
Orlando Ridout V 1981  
Post-and-Plank Meat House

To the south of the rear wing is a post-and-plank meat house. It is 12 feet square, oriented on a north-south axis, with the door in the center of the east wall. The exterior is covered with wood shingle siding and roof; the eaves are boxed. Beaded and tapered rakeboards have survived on the gable eaves; wide horizontal weather boards remain visible under the shingle siding.

Inside the meat house, the early post-and-plank framing is clearly visible. The planks are hewn and whip-sawn and average 2 1/2 to 3 inches thick by 8 to 9 inches wide. They are set into individual mortises in the corner posts and are secured with wood pegs driven in from the outside. The corner posts average 7 inches square and are reinforced with original

downbraces mortised into the posts. The horizontal plank walls are stabilized by vertical pegs driven down through the wall midway between the posts, similar to the pegged walls of the meat house at Cabin Neck (QA-204) on Kent Island.

The roof is the most unusual feature of the building. It is constructed of 25 rafter pairs, spaced so closely that only 2 to 3 inches separates each pair. Five "principal" rafter pairs are reinforced with collar beams that are half-lapped and nailed with wrought nails. The rafters are half-lapped and pegged at the peak and rest on flat false plates supported by the ceiling joists. The gables are framed with vertical studs nailed to the gable rafter pairs. Riven clapboard siding survives on the exterior of both gables, covered with later wide, sawn weatherboards. Other riven boards are nailed to the inner face of the gable framing with double struck nails. These boards and the unusual raftered roof are both evidently precautions taken to insure the security of the meat house. Both features are unique in Queen Anne's County.
